Hamakua Marsh (Kailua, O‘ahu) restoration site - 2011 plant monitoring survey

September 6, 2011

AECOS No. 1174C

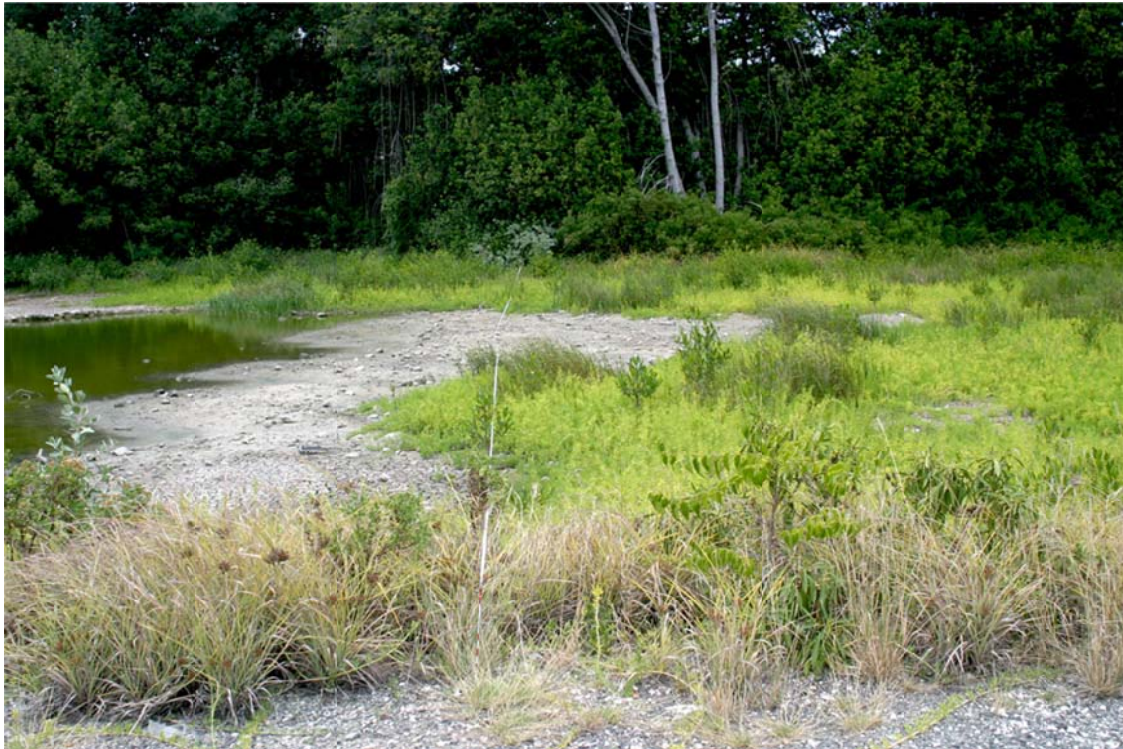
Figure 2. August 2011 view across central part of the wetland showing transect line laid out at Transect Mid. Base point is a surveyor's arrow set in the 'ahu'awa plants in the foreground.

For the August 2011 survey, five positions were located along the eastern shore where representative transects could be laid out across the wetland. A central base point was selected and then two base points to the north and two base points to the south were established, each base point being roughly 10 m (30 ft) apart. From each of the five base points on the eastern shore, a transect line was played out across the marsh to the western edge where there remains a staked geotextile fabric barrier marking the project area boundary.

An aluminum quadrat frame of dimensions 1.0 by 0.5 m, outfitted with a grid of heavy sugi thread spaced at 10 cm intervals, was used to quantify plant cover along the transects. The quadrat frame was placed on each side of the transect line creating a quadrat of dimensions 0.5 x 2.0 m (1 m²). The quadrat placement position along a line was determined by a position table constructed in advance. Three different tables were used, with 1 No/1 So and 2 No/2 So sharing tables). Each position table listed 5 randomly determined placements from the 20 possible placements in each 10-m section of the line. This stratified random

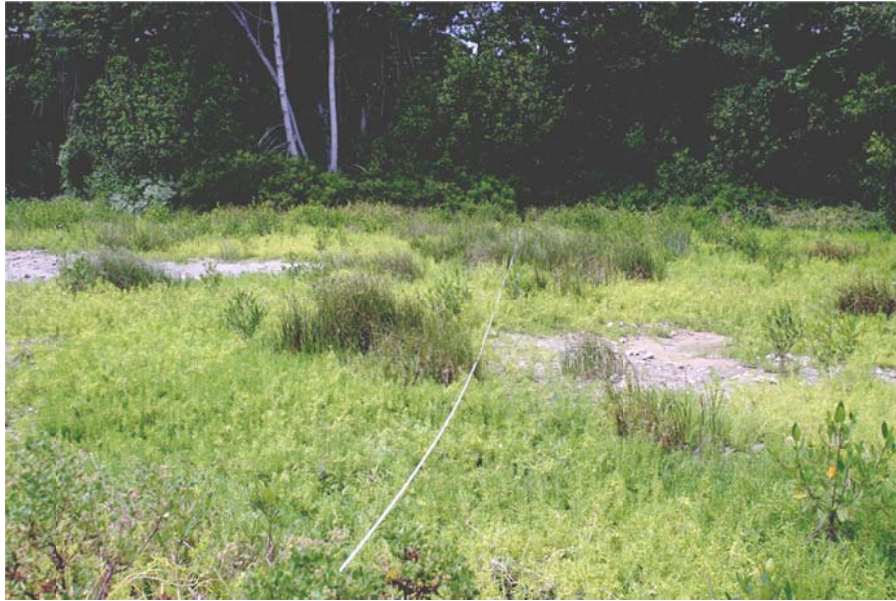
Figure 3. Northern portion of the Hamakua Marsh restoration site as it appeared in August 2011; view is along Transect 1 No.

In general terms, plant cover as of August 2011 can be described as substantial in the northern half of the restoration area (see Fig. 3), with roughly 15% of the

area lacking vegetation (Table 1, combining results from transects 1 No and 2 No). This condition differs considerably from that observed by our previous survey in June 2010, when bare substratum characterized a majority of the marsh area except along the very margins of the graded basin. However, the southern portion of the wetland remains a large pond (presumably with variable water level; see Fig. 4, above) and is likely to remain in this condition for some time, although there are indications of wetland vegetation invading the south and west shores. This open-water feature is attractive to *A'eo* or Hawaiian stilt (*Himantopus mexicanus knudseni*).

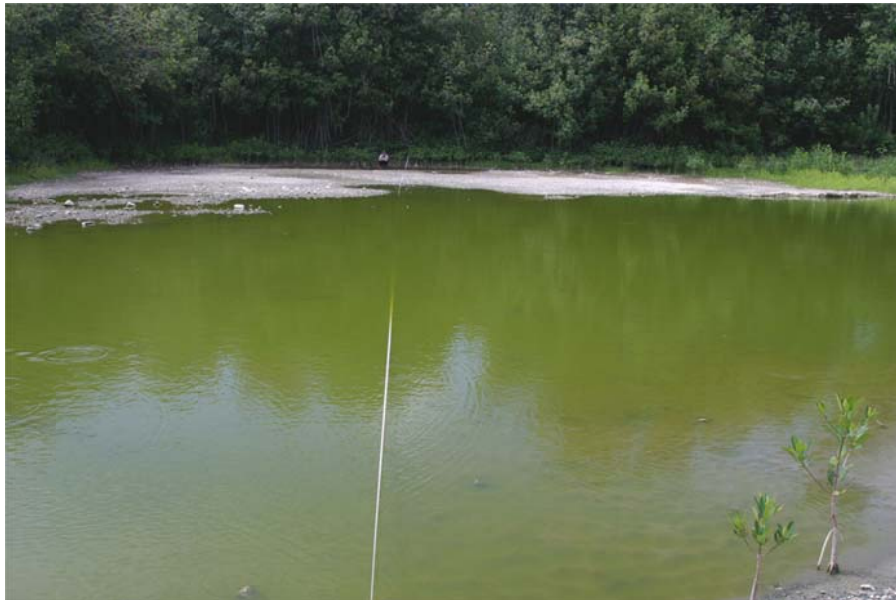
Figure 4. Southern pond area of the Hamakua Marsh restoration site as it appeared in August 2011; view is along Transect 2 So.

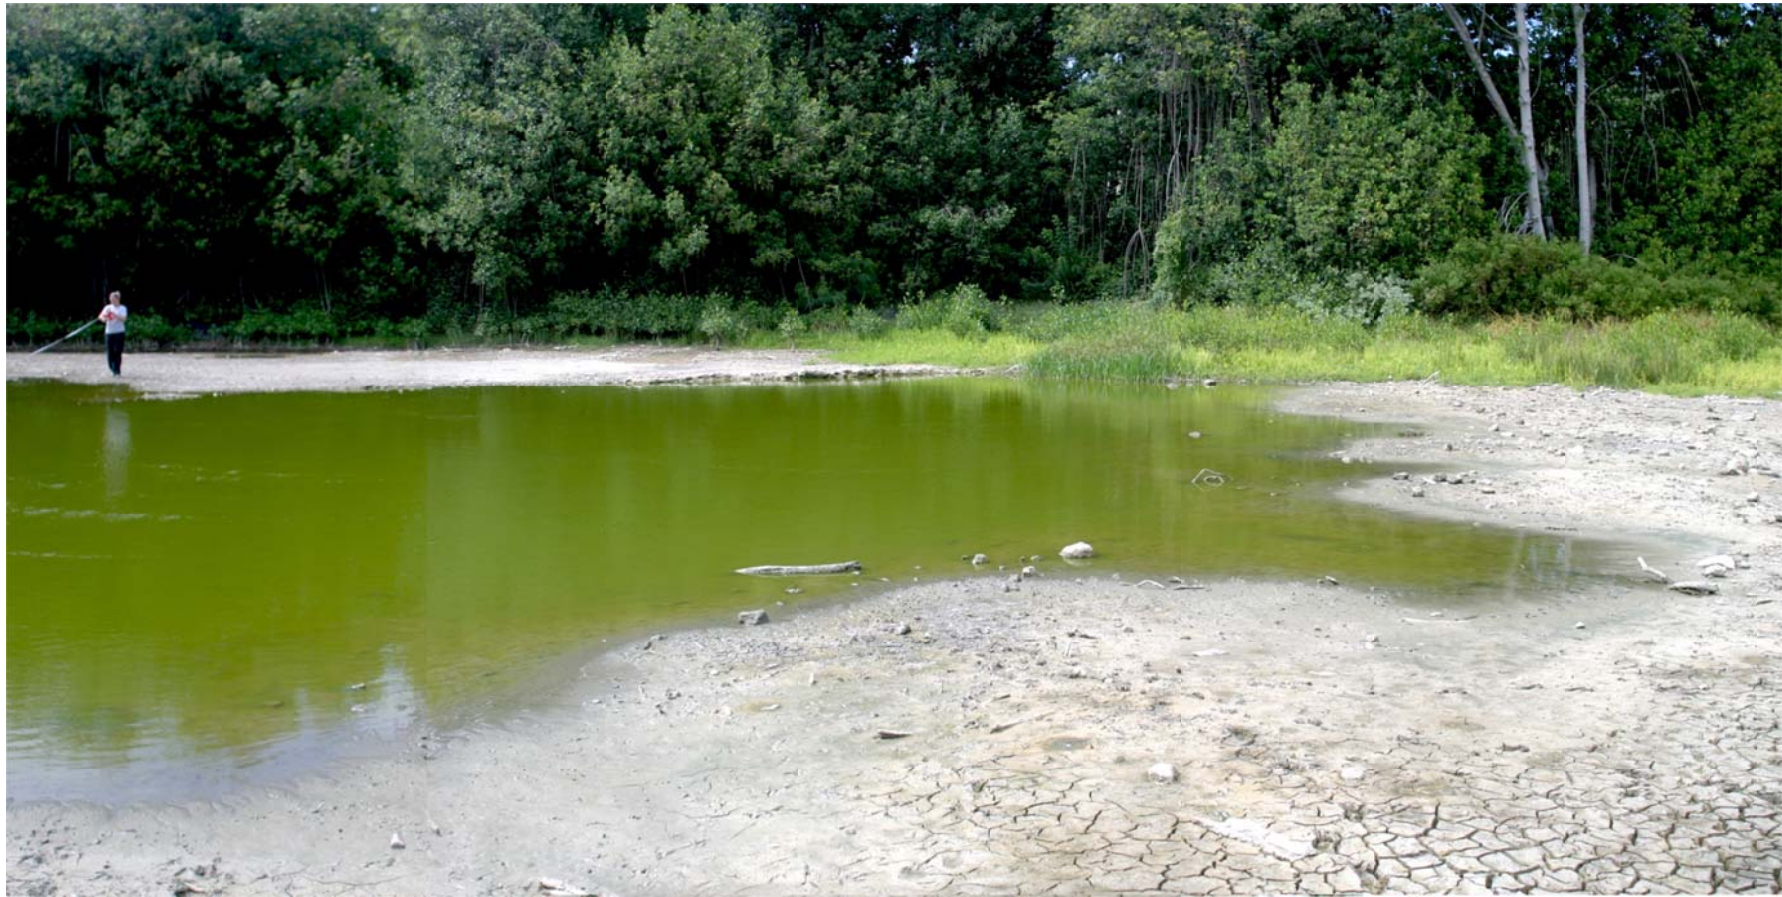
Figure 5. Panoramic view at Transect 1 So looking across a portion of the southern pond (Transect 2 So being reeled-in on left). Trees in background are red mangrove lining the Kaelepulu-Hamakua drainage canal.

The vegetation present at the Hamakua Marsh restoration site includes a number of native species, the most abundant being 'ae'ae (*Bacopa monieri*) at 7.5% of the marsh area. Two other native species—*kaluhā* (*Bulboschoenus maritimus*) at 3.5% overall, and 'ahu'awa (*Cyperus javanicus*) at 3.2% cover—are conspicuous. However, the dominant vegetation at this site is now pickleweed or 'akulikuli kai (*Batis maritima*) at 34.8% cover. This non-native shrub and red mangrove (*Rhizophora mangle*) are the dominant species in Hamakua Marsh generally. Although mangrove is presently only 2.5% of the restoration site, the mangrove plants are mostly saplings (in 2010, most were rooted seedlings). Mature mangrove trees line the western edge of the restoration area just outside the boundary (see Fig. 5).
